Re: Supplemental Response
Southeast Rockford Groundwater
Superfund Site (the "Site")

This letter is written in response to the questions which you raised during our November 29, 1990 meeting with respect to Sundstrand's CERCLA 104(e) Response dated July 24, 1990 to the EPA's Supplemental Request for Information dated June 20, 1990. The following points are numbered in accordance with the EPA Supplemental Request for Information dated June 20, 1990. Each item consists of Sundstrand's explanation and additional facts, if any.

Question No. 5 - you asked whether additional spills took place at the 4747 Harrison Avenue, Plant 6 location. Attachments 3 through 5 provided the responses for Question No. 5. They contain information describing applicable reportable quantity spills as defined by CERCLA and any spills reportable under other federal statutes, for example, the underground storage tank regulations.

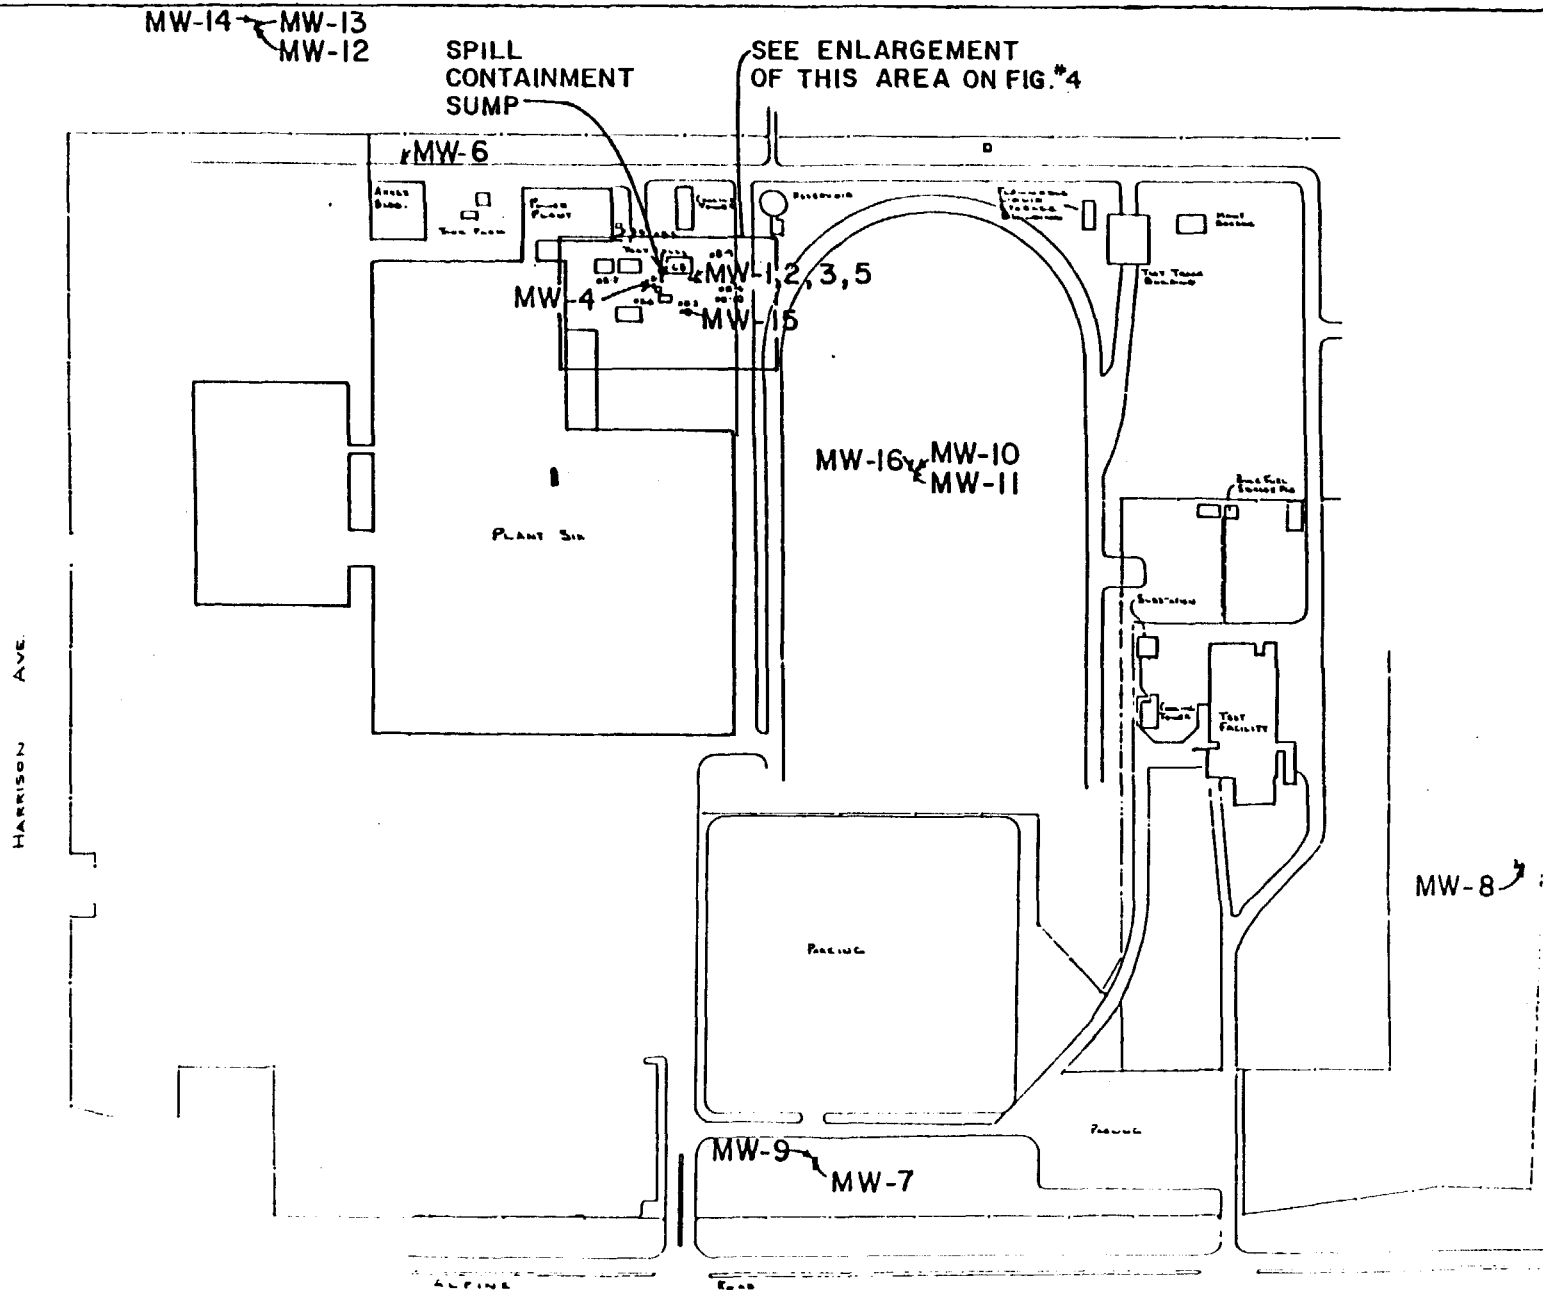
FIGURE No. 1

In an effort to determine if there was any groundwater contamination, Monitoring Wells 1, 2, 3, 4, 5, 6, and 7 were installed in November and December of 1984. These wells were located as shown on Figure #1. Monitoring Wells 1, 2, 3, 4, and 5 were installed at different depths to determine in addition to contamination, the hydrogeologic conditions adjacent to the suspected toluene release. Monitoring well 6 was installed as an upgradient monitoring well and Monitoring Well 7 was installed as a downgradient monitoring well. All monitoring wells were installed as follows:

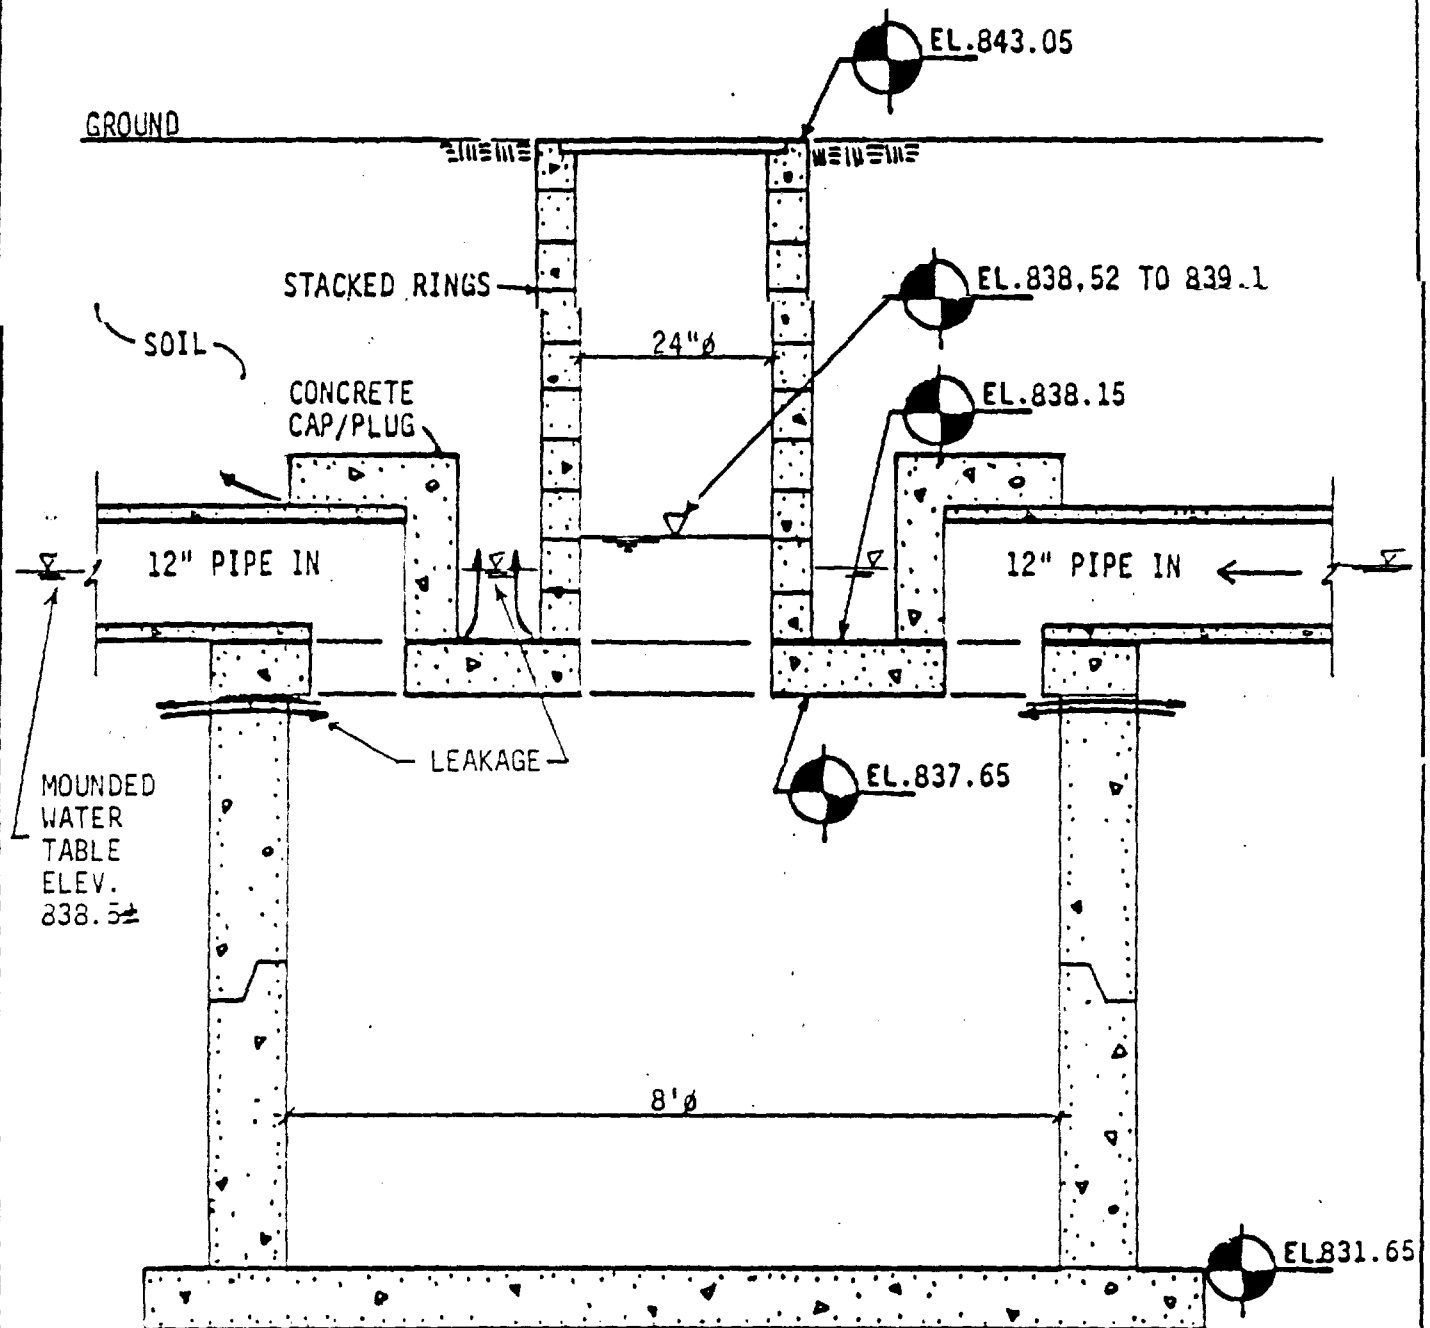
FIGURE No. 2

SPILL CONTAINMENT SUMP

The sump which allowed the toluene to be released has been removed. All drain lines connected to the sump have been plugged. The non-contact cooling water pipe leak was repaired and the mounded water table has thereby been eliminated.

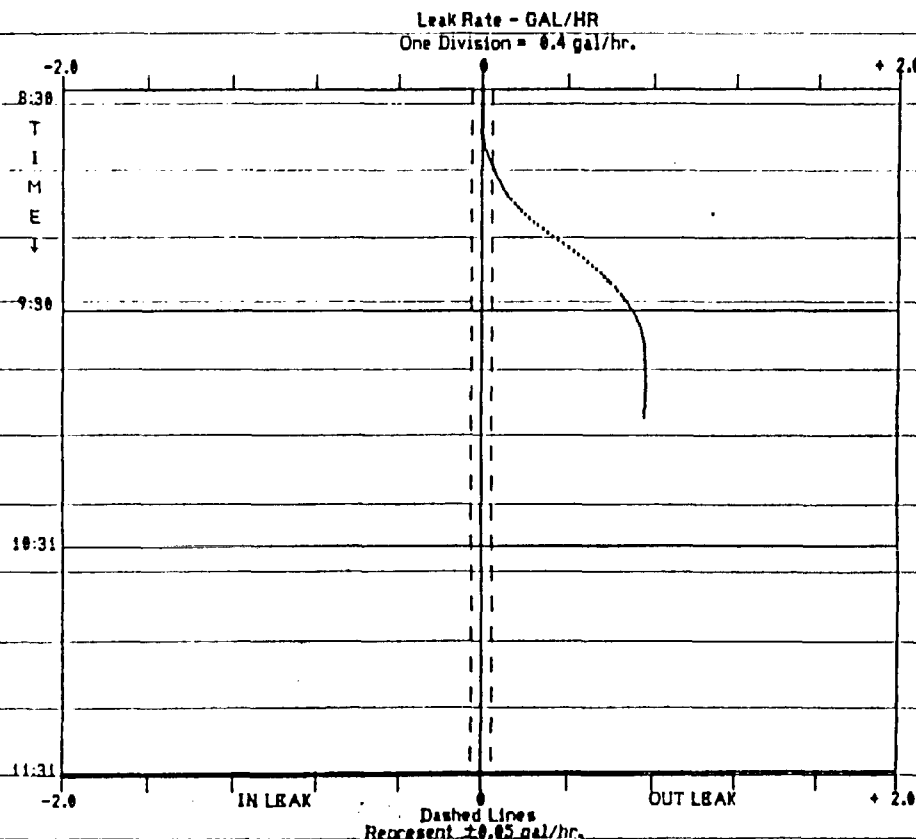
Leak Computer - Quick Look Report (PAGE 1)

Final Average Leak Rate: 0.6160 gal/hr.
 Rate of Temperature changes: 0.0045 °F/hr.
 Rate of Volume changes: -0.6026 gal/hr.
 0.99 Error Bands ± 0.08 gal/hr.
 Tank and System: FAIL at 60 Inches ABOVE Tank Top.
